SPEED DATA ANALYSIS

Speed Enforcement Evaluator

DEAN STREET

STATION ROAD

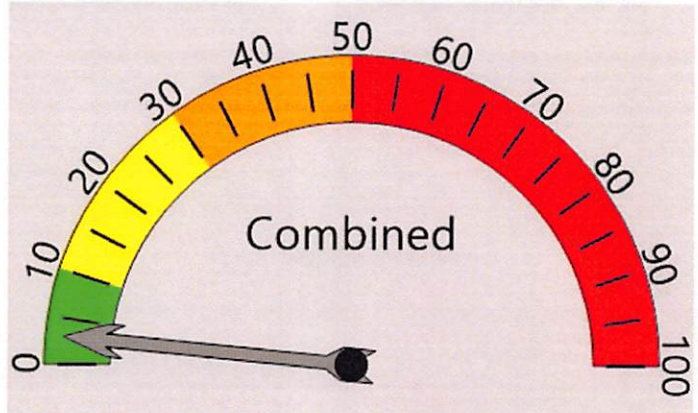
Total Percentage of Enforceable Violations

Posted Speed Limit 25 MPH
Enforcement Tolerance 10 MPH
Enforcement Limit Greater than 35 MPH

Percent Speeding: 3%

Rating: Low
