SPEED DATA ANALYSIS

Speed Enforcement Evaluator

ROSEDALE AVENUE

PARKSIDE AVENUE

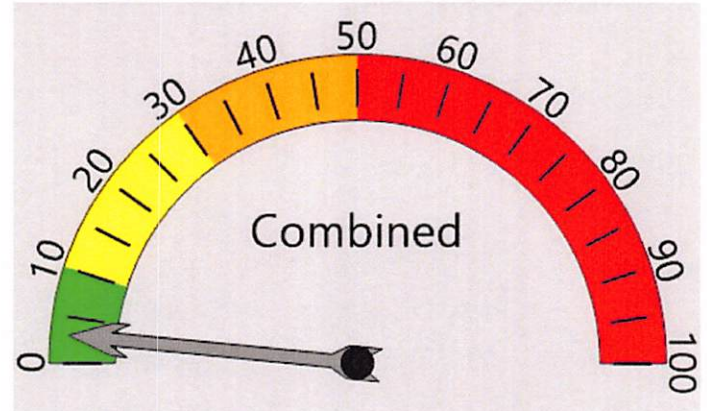
Total Percentage of Enforceable Violations

Posted Speed Limit 25 MPH
Enforcement Tolerance 10 MPH
Enforcement Limit Greater than 35 MPH

Percent Speeding: 3%
Rating: Low

Percent Speeding: 2%
Rating: Low

Percent Speeding: 5%
Rating: Low
